Limited Indoor Air Quality Investigation

Antelope Valley College
3041 West Avenue K
Lancaster, CA 93536-5426

Performed on November 25, 2013

HSA Project Number 140058LA

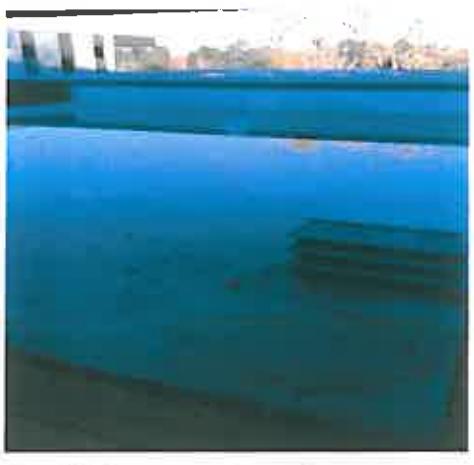
No. 15 – SSV roof with pooled rain water

- 7.4.1 During air sampling, HSA observed significant pooling of rain water on the roof areas. HSA recommends inspection of the roof for potential breaches in the roof protective membrane and check the drains and gutters for excess debris build-up.
- 7.5 This report was prepared for use by Antelope Valley Community College in evaluating the subject suite. The information contained within this report is as factual as possible and the opinions related herein are based on HSA's experience in similar investigations. No warranty, therefore, is made to any persons other than Antelope Valley Community College regarding the conclusions or recommendations included within this report. HSA will not release copies to a third party without prior written consent of Antelope Valley Community College.

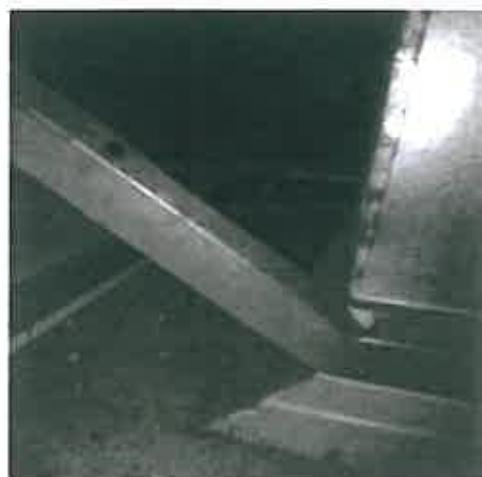
- 2.6.3 Residual debris surrounding a supply vent in SSV office 192 was observed (photo number 16).
 - 2.6.4 Sporadic rodent droppings were present over SSV offices 190, 191, and 192 (photo number 17).

No. 16 – SSV office 192 plenum, debris
surrounding supply vent

- 7.2.1 Based on the inspections of the ceiling plenum space over SSV offices 180 - 197, HSA recommends further clean up of these areas. It was indicated to HSA that the ceiling plenum space was cleaned by an outside contractor, however, the areas surrounding all supply and return vents should be re-cleaned as debris and rodent droppings were observed during HSA's site visit of November 25, 2013. Also, to counteract a persisting rodent issue it is recommended that periodic surveillance of the plenum space be implemented to avert the potential of an increased infestation.

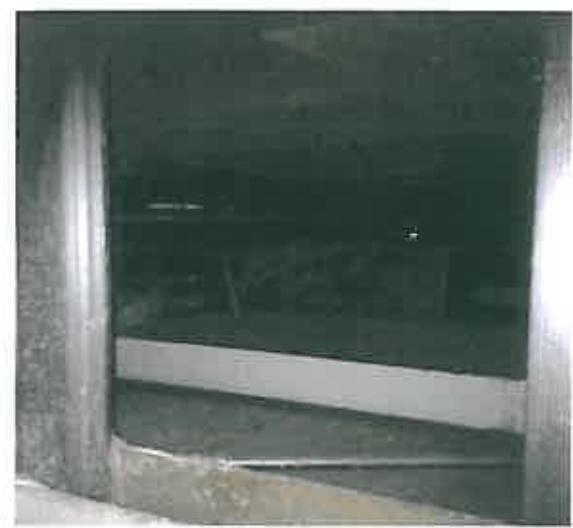
No. 18 – SSV office area 190 plenum, breach in
HVAC duct

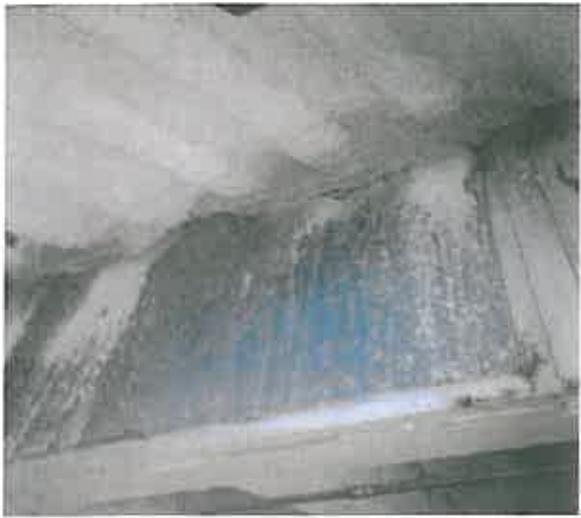
- 2.6.6 Over SSV office 192, minor water intrusion and damage to fireproofing was observed where the sloped-roof and original building meet (photo number 19).

No. 19 – SSV office 192 plenum, water intrusion
at sloped roof and original building decking

- 7.2.2 HSA observed water intrusion over SSV office 192 where the sloped roof and original building "egg-crate" decking meet. HSA recommends that this be addressed and all breaches in the roof be inspected and sealed.

- 7.2.3 Subsequent to HSA's site visit, it was reported that an AVC crew inspected this area of the building and traced by the water stain to what appeared to be its origin, and re-sealed that area.
